**Virginia Department of Mines, Minerals &
Energy
Division of Mines**

**Accident Investigation Report
Underground Coal Mine
Preparation Plant**

**Fall of Person Fatality
December 5, 2000**

**Consolidation Coal Company
Buchanan No. 1 Mine
Mine Index No. 11912AA
Buchanan County, Virginia**

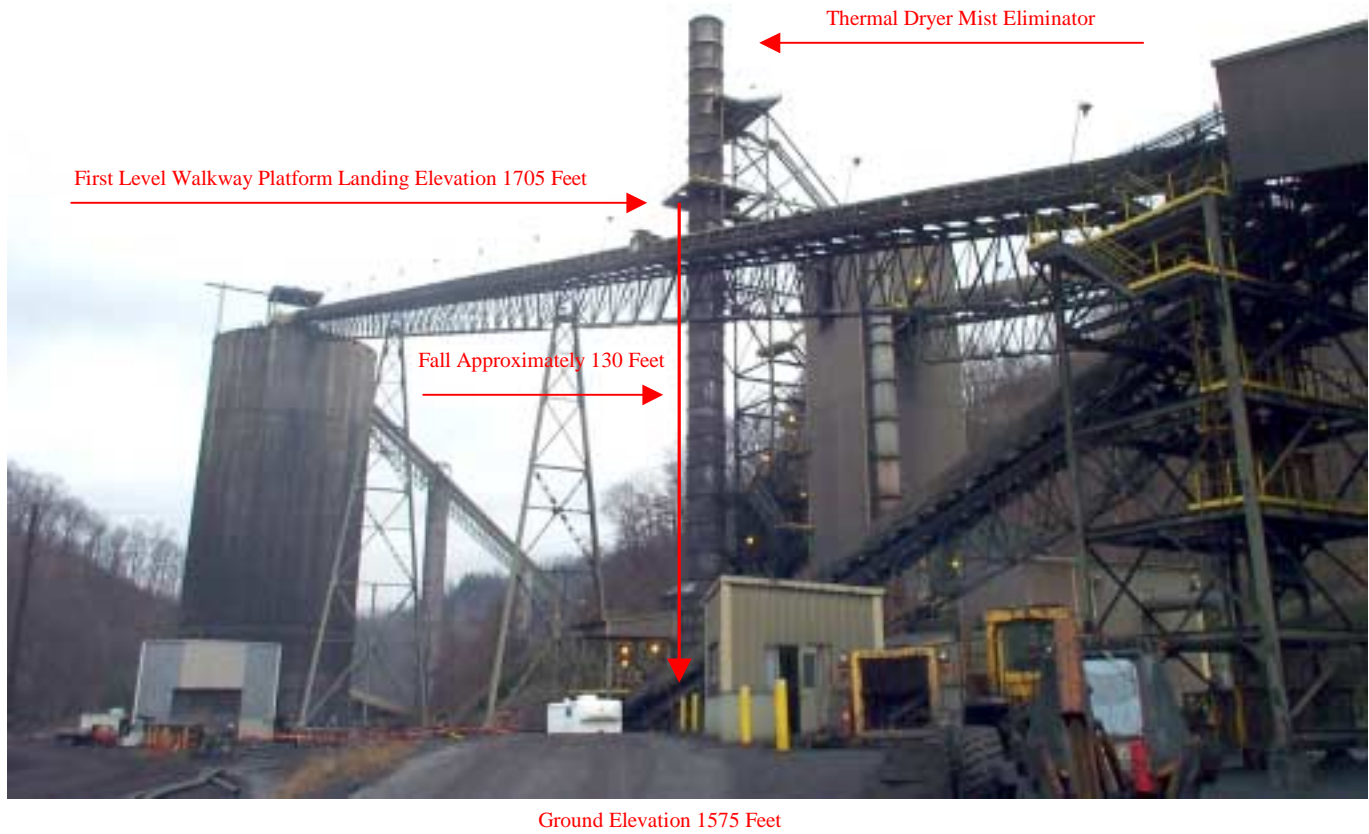
Ground View of Thermal Dryer Stack

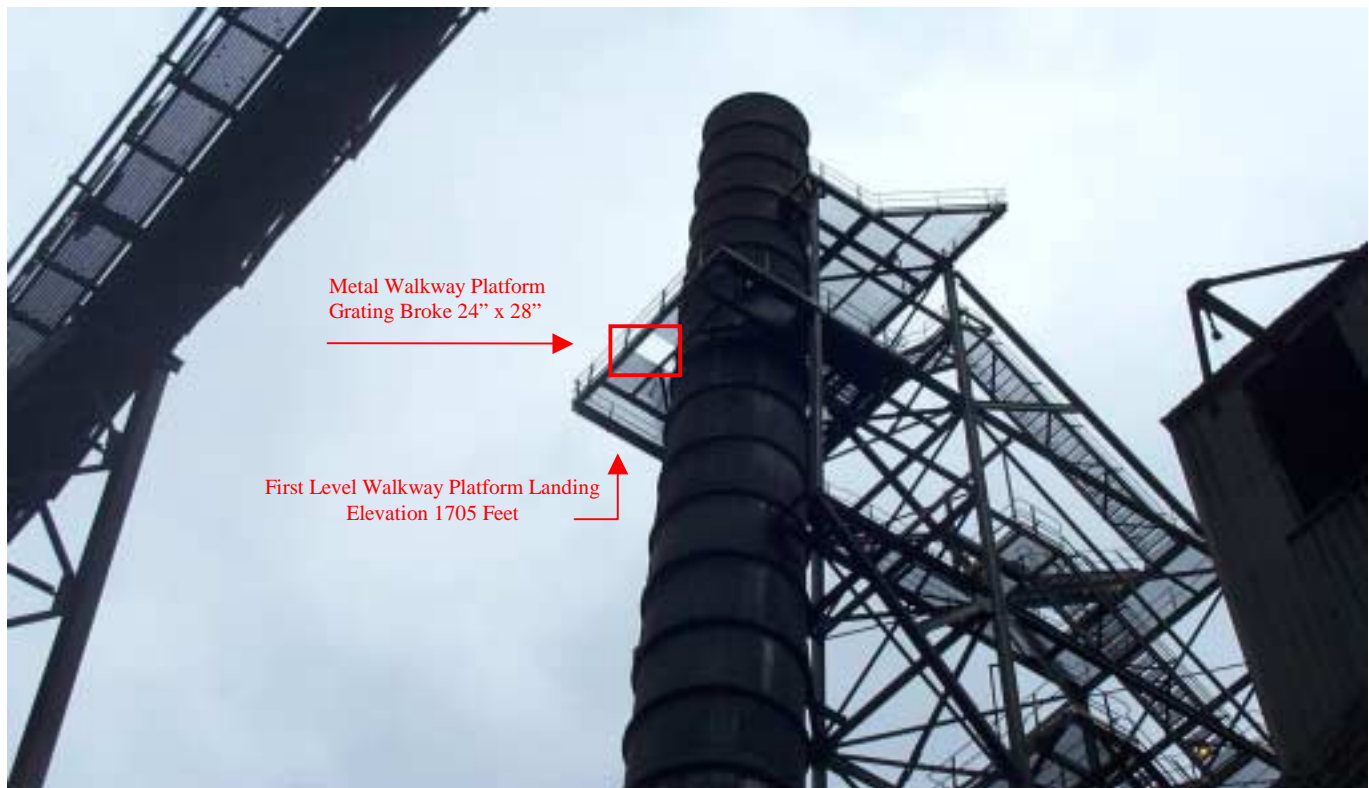
View From Ground Level Looking Up To
First Level Walkway Platform

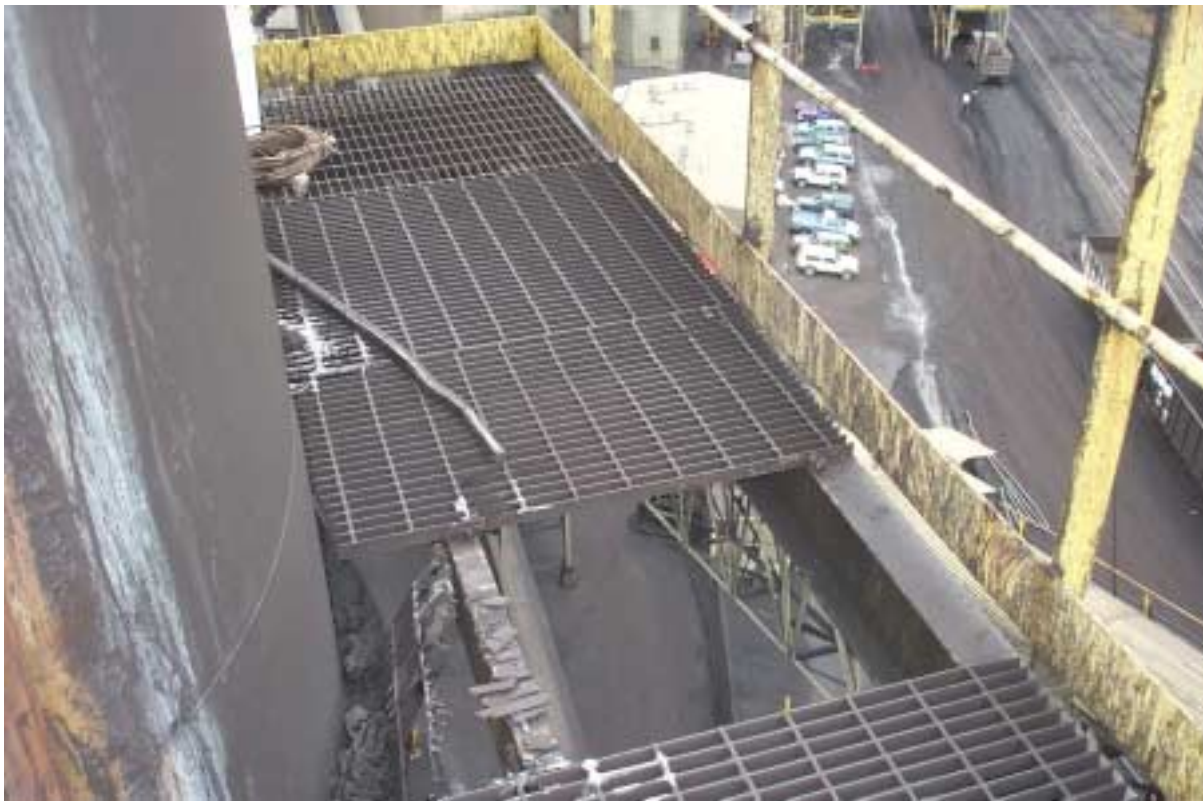
First Level Walkway Platform Landing - Location Where Grating Broke and Fell

4. The gate-covered slots located immediately over the first platform walkway landing where the accident occurred would not seal to prevent moisture and grit escaping from the thermal dryer stack and settling onto the walkway platform.

9. The piece of metal walkway grating that broke and fell from the first platform walkway landing was corroded and deteriorated.
10. Two other sections of metal walkway platform grating on the first landing where the accident occurred were also corroded and deteriorated. One of the deteriorated sections was located adjacent to the piece that broke loose and fell.

1. The operator should develop and implement a planned inspection program for all plant platforms, stairways and other travelways where personnel are required to travel and work. Inspections should be performed by trained and experienced persons. Priority during inspections should be given to those locations where conditions and experience indicate the highest risks for metal deterioration and fatigue.

2. Elevated platforms, stairways and runways shall be kept clear of stumbling and slipping hazards and shall be maintained in good repair.
3. Elevated platforms, stairways and runways that are traveled infrequently should be examined for hazardous conditions by preparation plant officials prior to anyone traveling or performing work in such areas.

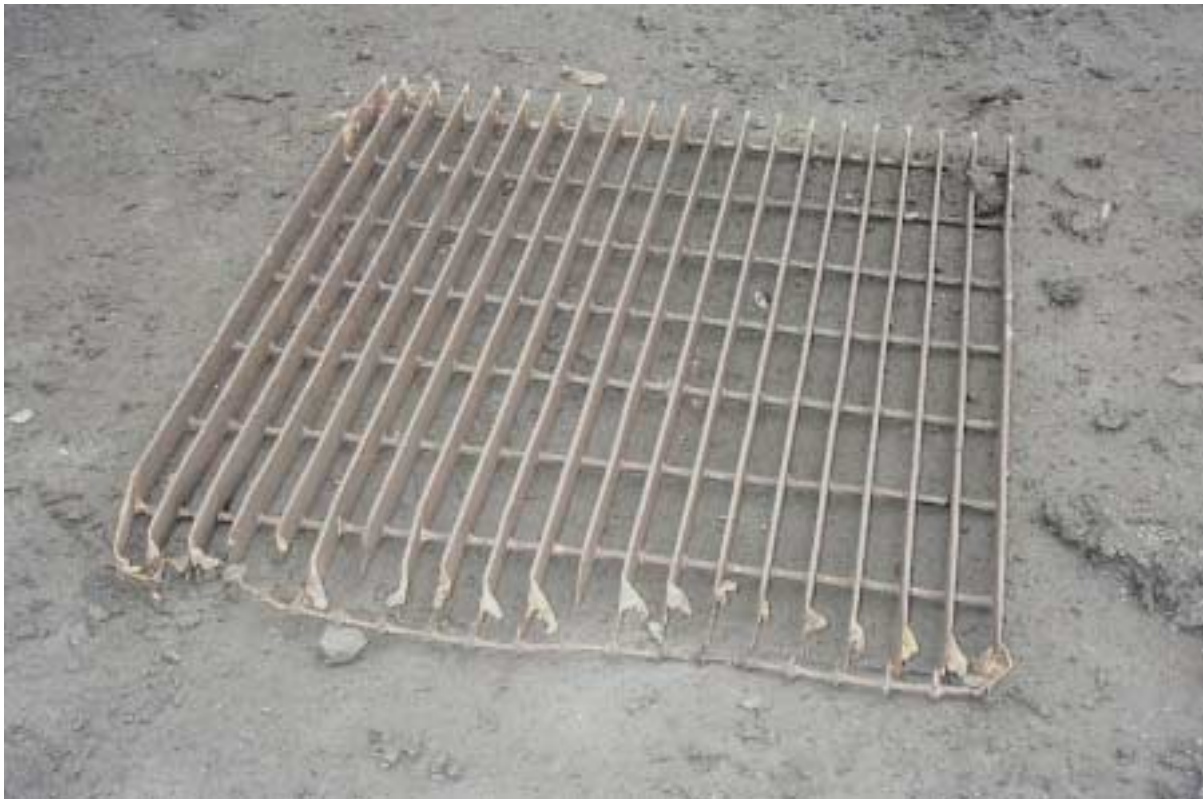
Piece of Grating that Broke and Fell from the First Level Walkway Platform Landing

10. Mine personnel stated that the thermal dryer was not operating at the time of the accident on December 5, 2000.
11. Mine personnel stated from experience that metal walkway grating deteriorates more at locations where the grating contacts or crosses over other structural material such as support beams. The piece of walkway grating that broke and fell at the first platform landing causing the accident broke loose at a location where a section of grating crossed over the top of a metal support beam. Mine personnel also stated that deterioration of metal grating in these areas results from accumulation of water, ice, coal dust and other debris.

11. The section of metal walkway platform grating where the accident occurred measured approximately 24 inches by 38 inches and the piece of this section that broke and fell measured approximately 24 inches by 28 inches. The piece of metal grating that broke loose and fell had deteriorated where the grating crossed over top of a metal support beam. A remaining piece of grating, measuring approximately 14 inches by 10 inches, was lodged against the thermal dryer mist eliminator stack on the first walkway platform landing. Several smaller pieces of corroded grating material were observed lying on top of the steel support beam.

12. Mine personnel stated that deteriorated walkway grating requires regular attention and replacement. The deteriorated walkway grating is replaced with galvanized metal grating.

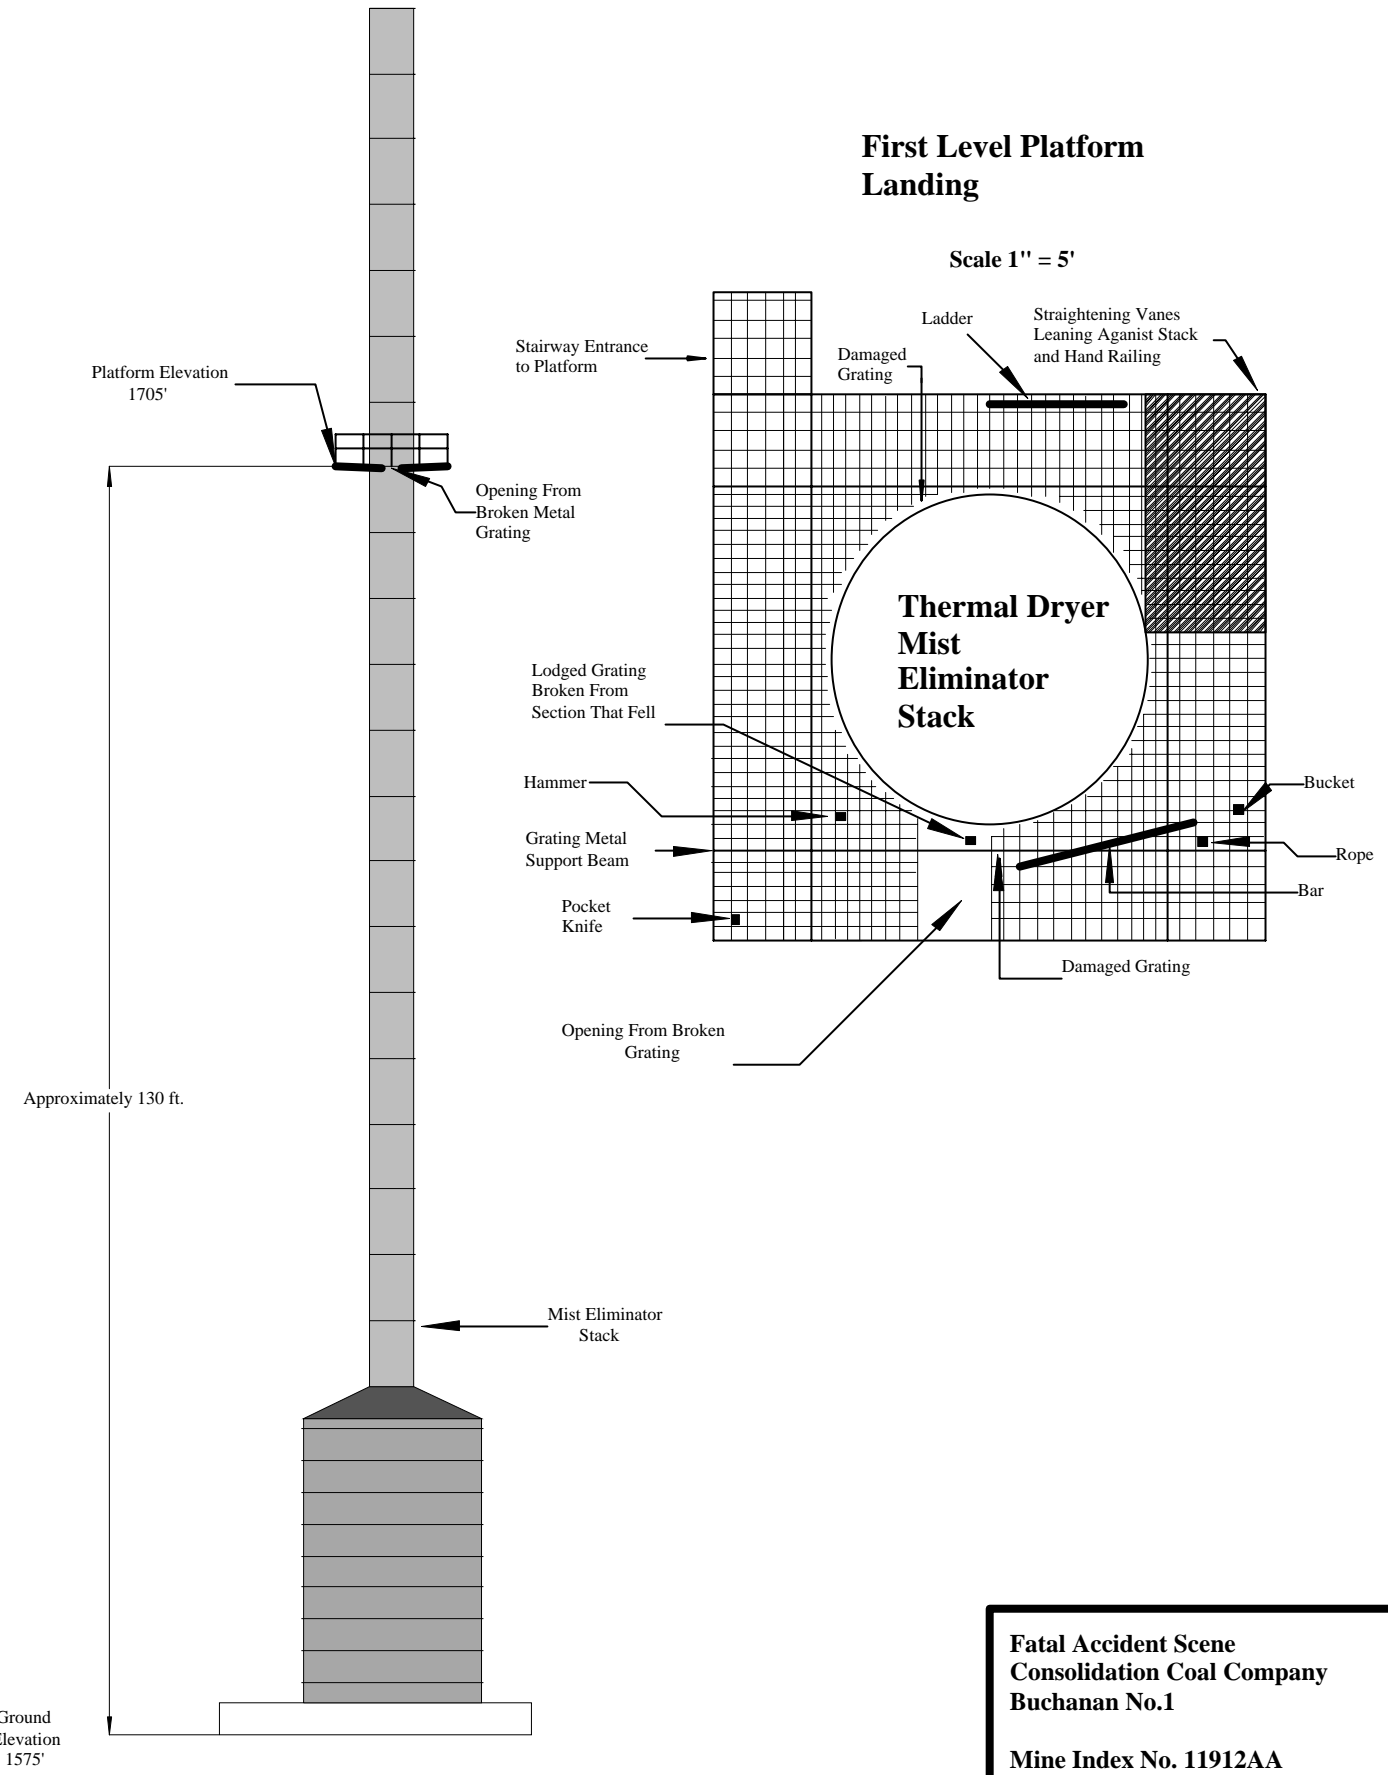
**First Level Platform
Landing**

**Fatal Accident Scene
Consolidation Coal Company
Buchanan No.1**

13. The first platform walkway landing where the accident occurred was approximately 15.66 feet in length and 38 inches minimum in width. The platform walkway landing was constructed of one and one-half inch by one-eighth galvanized bar grating mounted on top of steel support beams. The walkway grating was connected to the support beams with metal clips. The steel support beams are spaced on 34 inch centers.

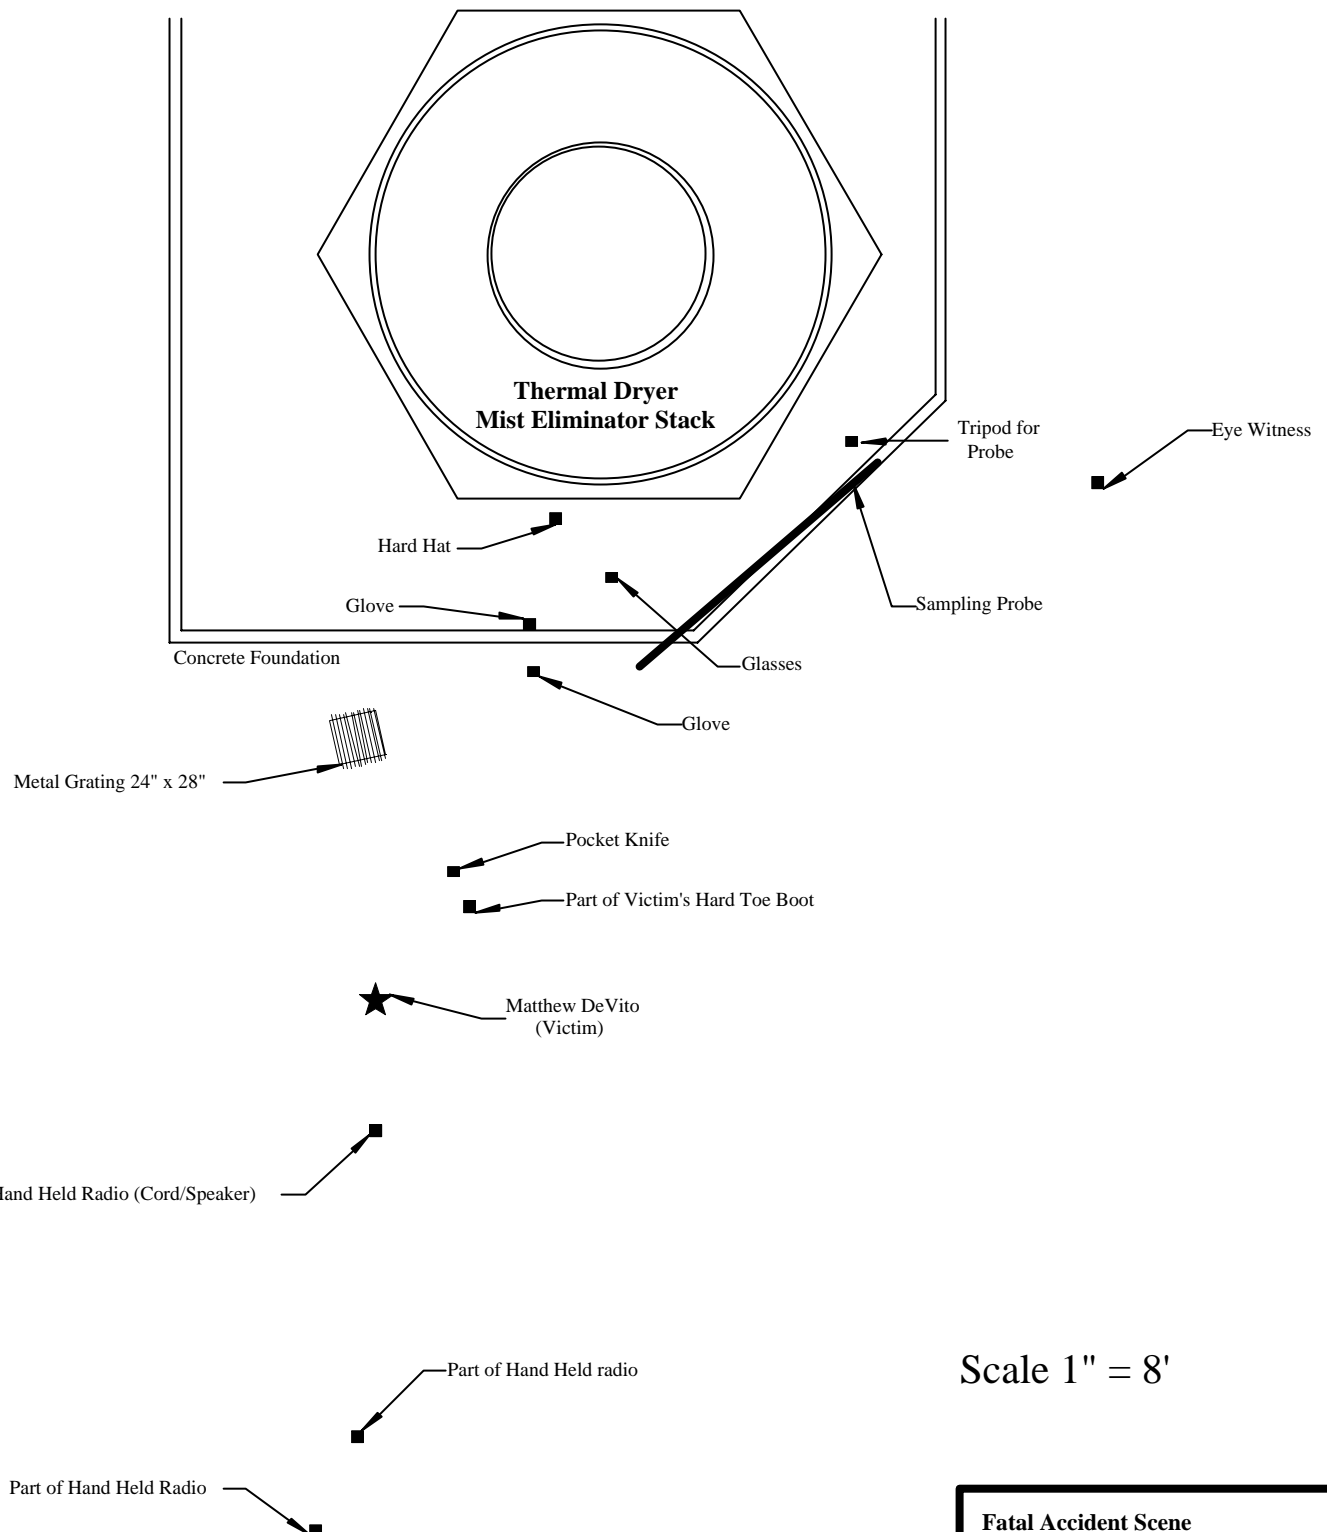
**Preparation Plant - Thermal Dryer
Mist Eliminator Stack - Ground
Level View**

**Fatal Accident Scene
Consolidation Coal Company
Buchanan No.1**

8. Mr. DeVito fell from the first platform walkway landing to the ground below, a distance of approximately 130 feet.
